# Defect Detection in Photovoltaic Modules using Electroluminescence Imaging

Electroluminescence (EL) imaging for photovoltaic applications has been widely discussed in the last years. In this contribution, the results of an all-around evaluation of this technique in regard to defect detection and quality assessment in photovoltaic modules are presented. The aptitude of the EL system for detecting failures and deficiencies in both crystalline and thin film PV modules (CdTe and CIGS) is thoroughly analyzed and an exhaustive defect catalogue is established.

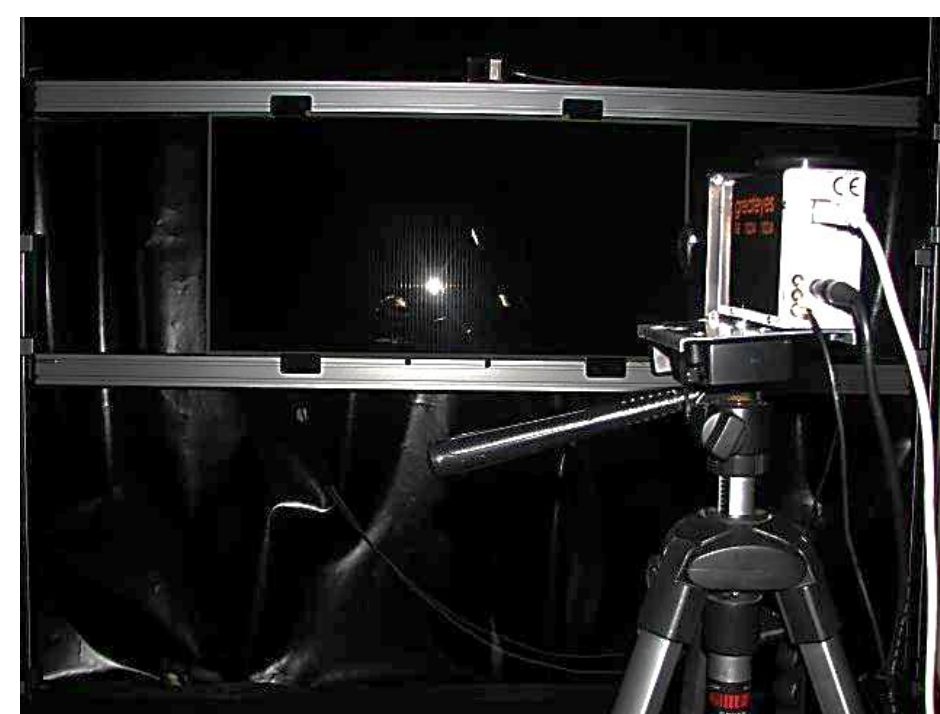
Camera setup inside the black tunnel

The setup consists of a back-illuminated Si-CCD camera with a high near infrared sensitivity mounted on a freely movable tripod inside an extra dimmed black tunnel. The system allows for overall shots of complete modules (size up to 2m x 2m) as well as for close-up measurements of different module sections with a minimum camera-object distance of 30 cm.

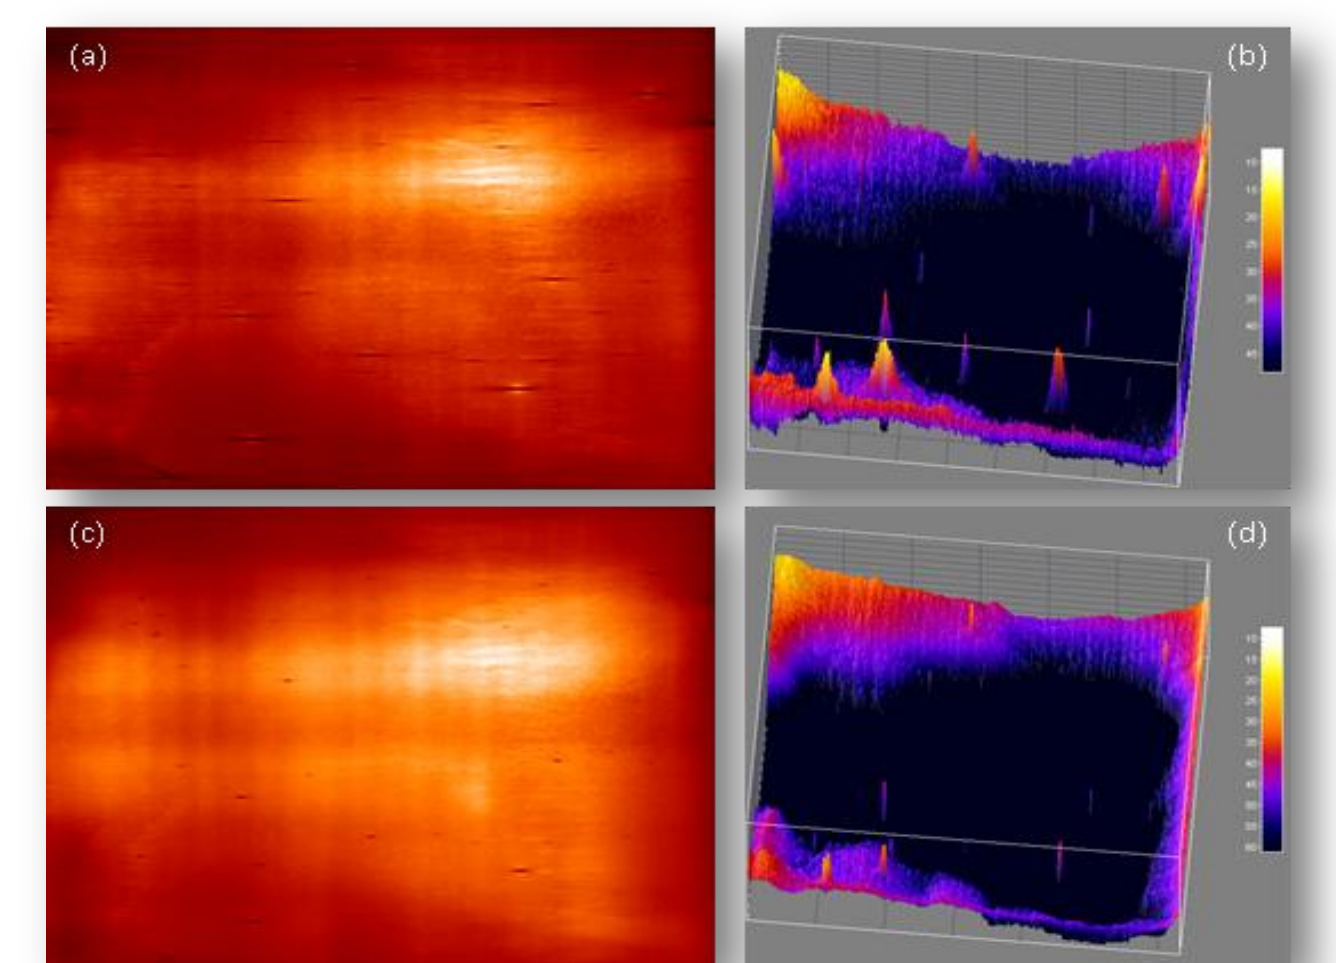
EL-measurements showing shunts in CIGS-modules and demonstrating the effect of light soaking on their size ((c) and (d) compared to (a) and (b)).

EL showed a good suitability for detecting shunts in thin film modules. These common defects, especially in CIGS-based modules have a very particular EL brightness pattern: a localized darkness within a single cell having a particularly dark (in some cases a particularly bright) center and a symmetric appearance along the cell.

It could be shown through the comparison of EL-measurements that light soaking remarkably affects the size of the shunts and thus their impact on the module performance. A rise of up to 8% in the output power could be noticed after 24h of light soaking treatment.

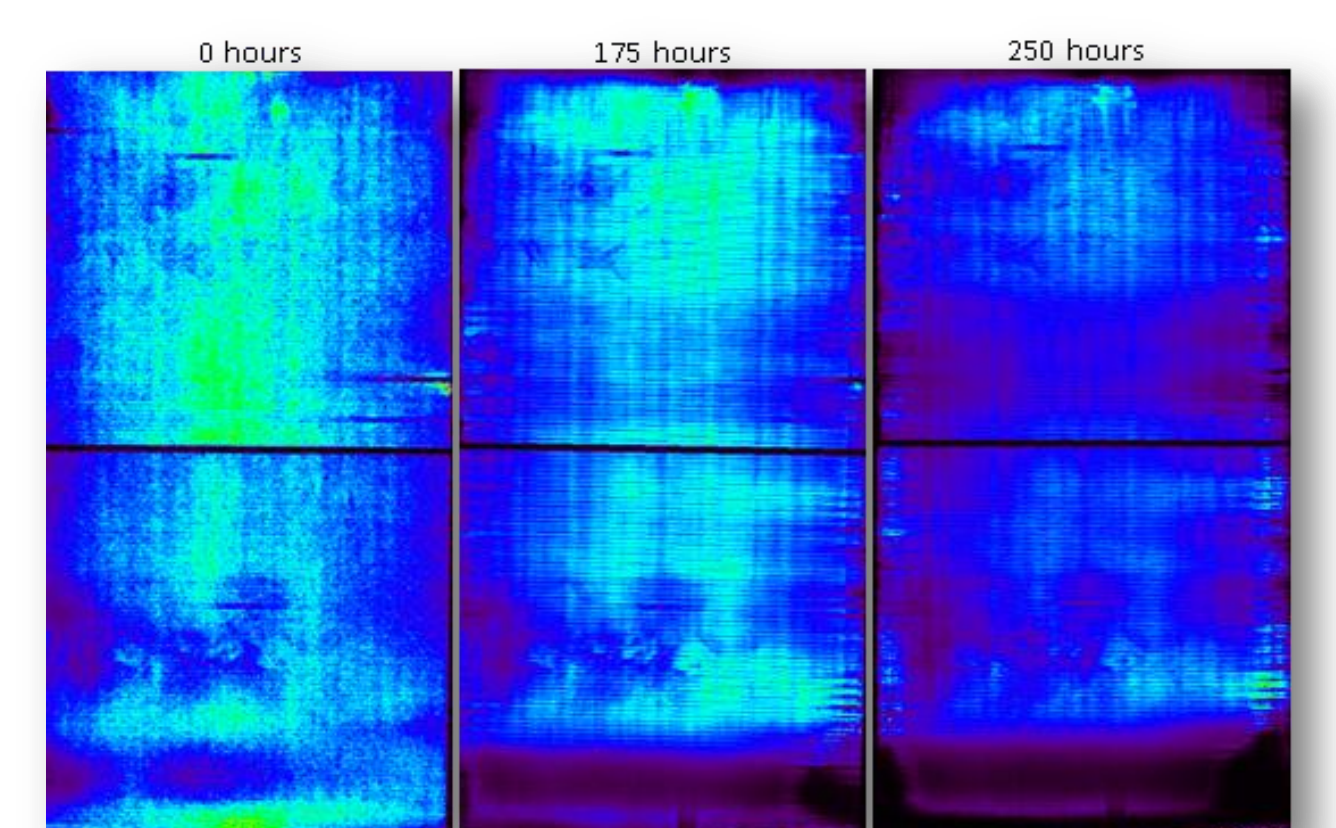
EL-measurements showing zones of corroded TCO in a thin film CdTe module under the effect of stress conditions (1000V in reverse-bias at 85°C and 85% relative humidity)

Additionally, the measurement setup allowed the detection of TCO-corrosion zones, induced by high negative voltages at high temperatures and humidity levels. Since the moisture penetration occurs at the module edges, the dark areas are concentrated in the outer zone of the module.

A linear dependence between the corroded area (darkness in the EL image) and the power drop could be shown.
